DOCUMENT NO. T5-6539-99

TITLE METALLURGICAL ANALYSIS OF BACB30GZ8 FASTENER FAILURES.

504 VEHICLE FUEL TANK

MODEL NO. Saturn V/S-10 CONTRACT NO. NAS 8-5608

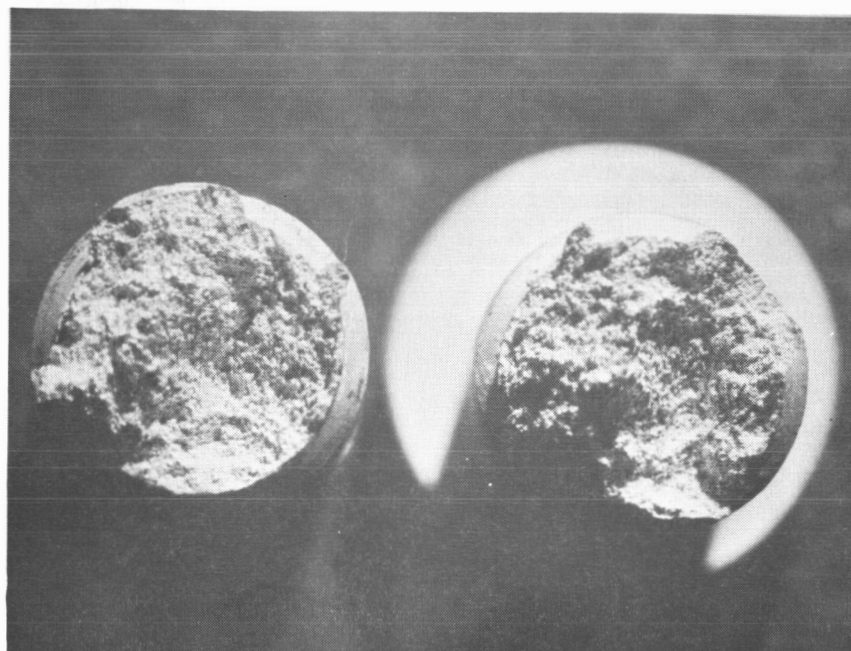
Fractographic study at 7X to 30X using a wide field stereoscope revealed fracture surfaces typical of stress corrosion cracking in fasteners of this type. Figures 2 - 7 are fractographs of each specimen showing a distended surface characteristic of the expansion associated with corrosion in aluminum alloys. Microscopic study of metallographic specimens at 100X and 500X revealed all fractures to be intergranular, with secondary intergranular cracking. This type of fracture mode and crack pattern is typical of stress corrosion cracking in 7075-T6 aluminum alloy. Figures 8 - 13 show the results of microscopic examination. It was noted in specimen number four, shown in figure eleven that although failure was in the head to shank transition stress corrosion cracking was also observed in the thread region.

FIGURE 3 - FRACTURE SURFACES, SPECIMEN 2, 8X

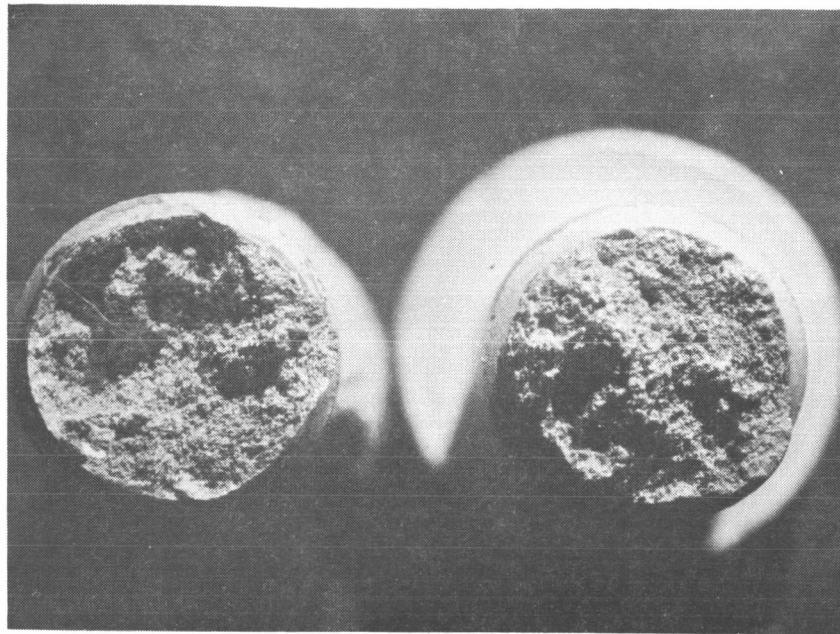
FIGURE 4 - FRACTURE SURFACES, SPECIMEN 3, 8X

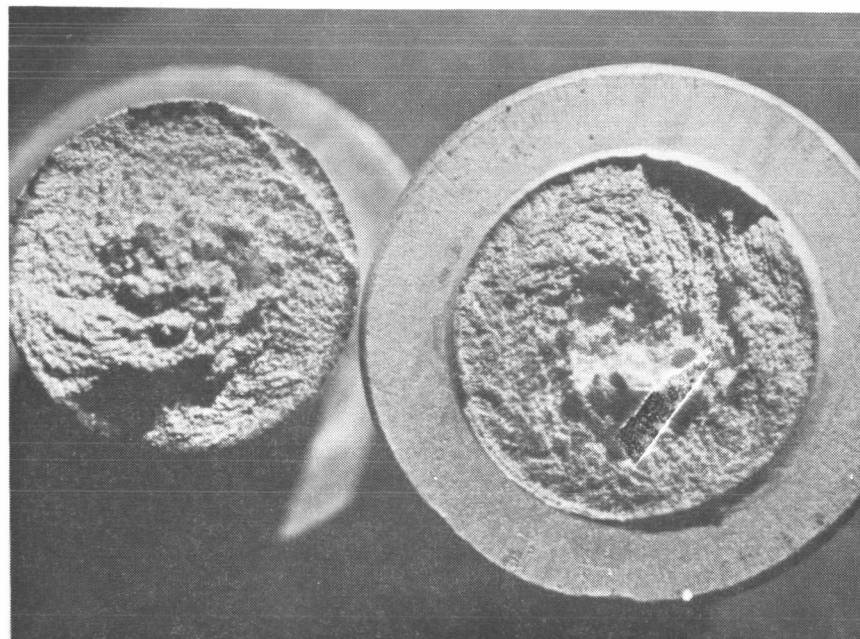
FIGURE 5 - FIGURE SURFACES, SPECIMEN 5, 8X

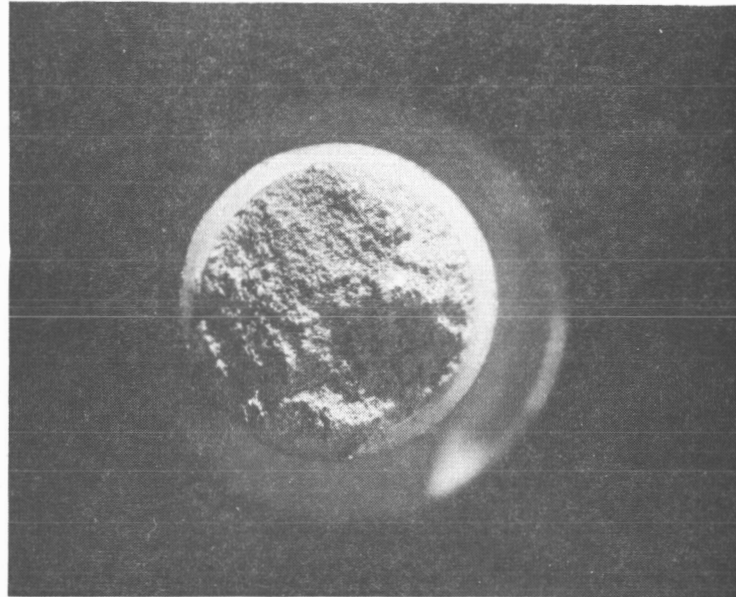
FIGURE 6 - FRACTURE SURFACE, SPECIMEN 5, 8X

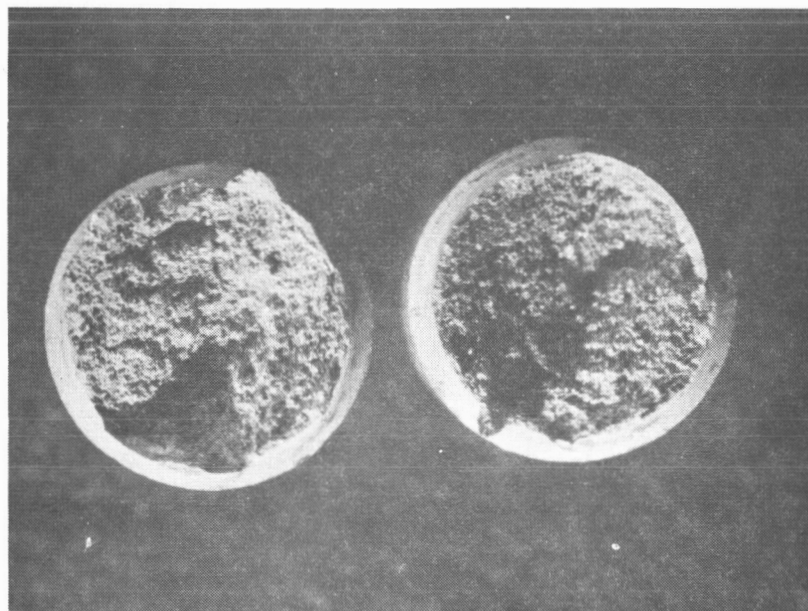
FIGURE 7 - FRACTURE SURFACE, SPECIMENS 6 and 7, 8X

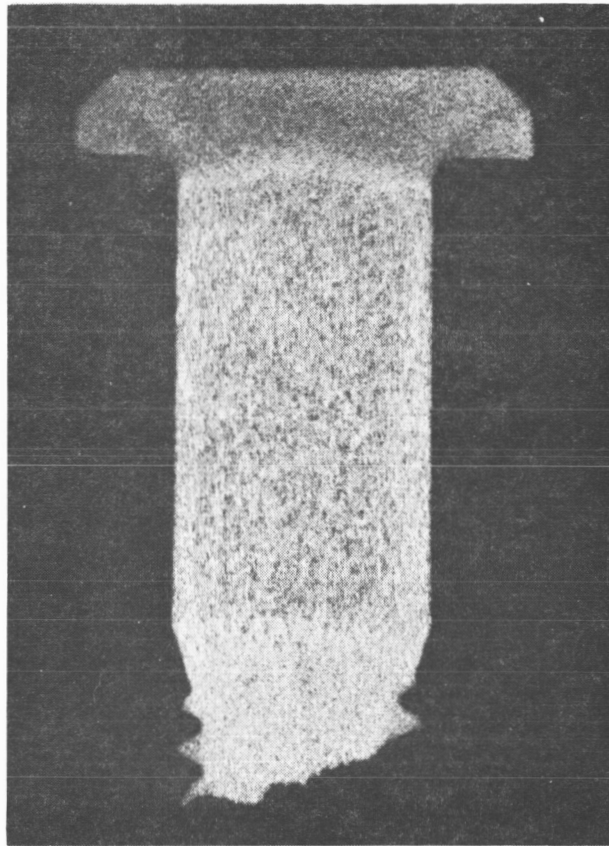
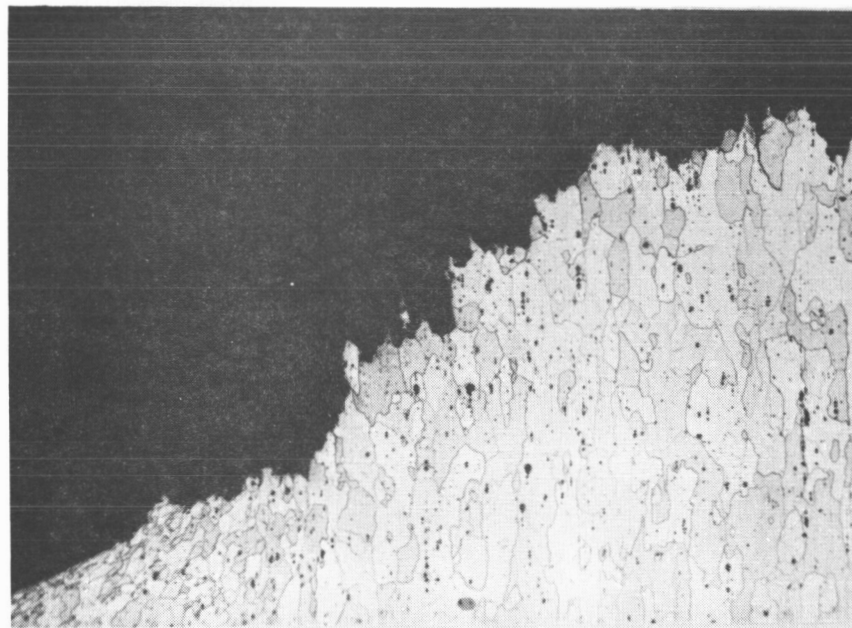
FIGURE 8 - MICROSTRUCTURE, SPECIMEN 1

It is concluded that seven BACB30GZ8 fasteners from the 504 vehicle fuel tank failed by stress corrosion cracking which initiated at areas of recrystallization.

It is recommended that these fasteners be manufactured as stated in T5-6539-93, i.e., to remove the unfavorable recrystallized grain in the threads and in the head. This can be accomplished by doing all forming after solution heat treatment. An alternate solution would be the use of BACC30PR collars which induce lower preloads.
